911 Crankshaft Oiling Groove

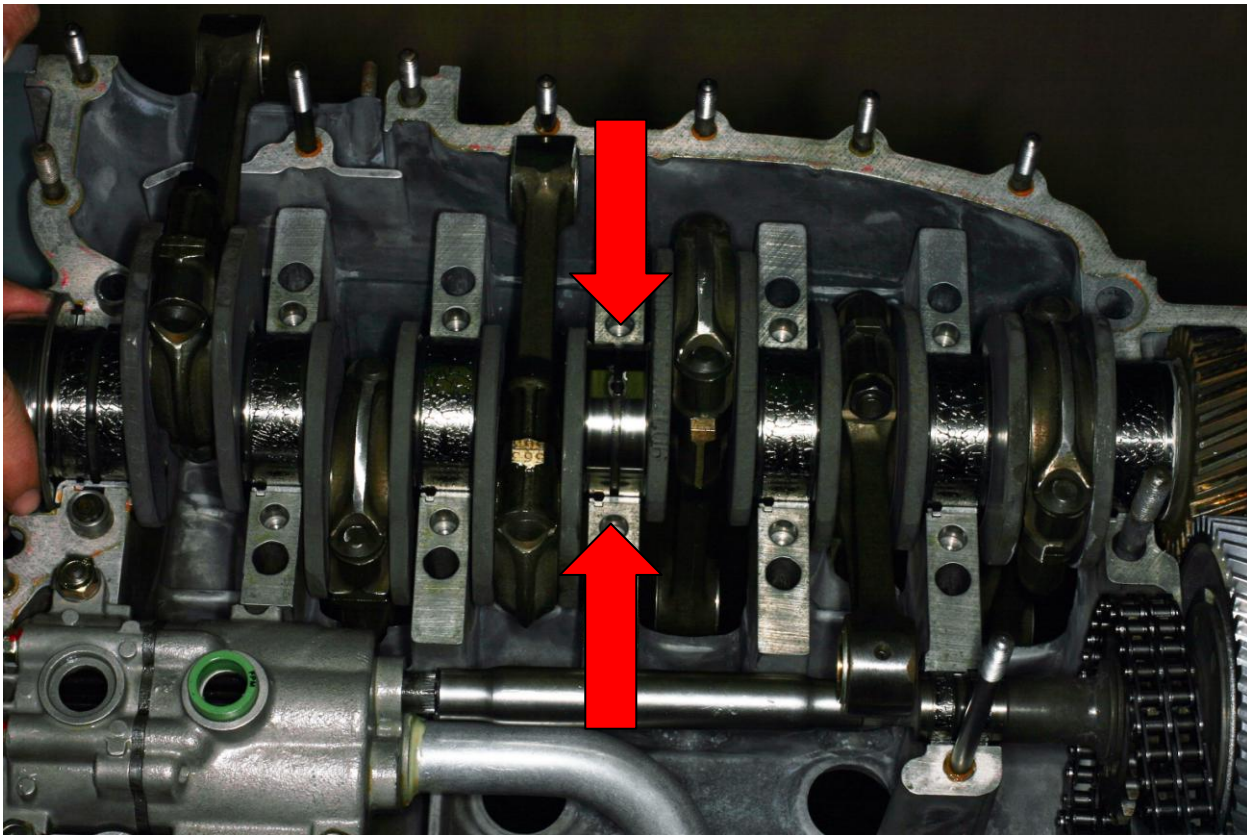
This is sometimes called, “center fed oiling” or center grooving. The accompanying pictures show which main journal gets the work performed on. The second picture is a close up of the groove.

There have been numerous #2 and #5 rod bearing failures attributed to lack of *oil scavenging or stagnation* occurring on either or both of the connecting rod bearings. The oil is fed through the crankshaft to the #2 and #5 connecting rods from both the #1 and #8 main bearings; oil to the main bearing occur directly from the engine case. With oil pressure and flow, the oil reaches both bearings but reaches the restriction/bottleneck at the #4 main bearing; this restricts the oil from flushing the bearings at the #2 and #5 connecting rod bearings. This stagnation can cause an overheat of the bearing and the resultant failure.

This repair is recommended for engines used in ANY TYPE of competition. This applies to all models. I have personally never witnessed this failure in a street engine.
